## Corrosion Detection and Surface Repair with Coatings on Condensate Storage Tanks Internal Surfaces

Nuklearna elektrarna Krško

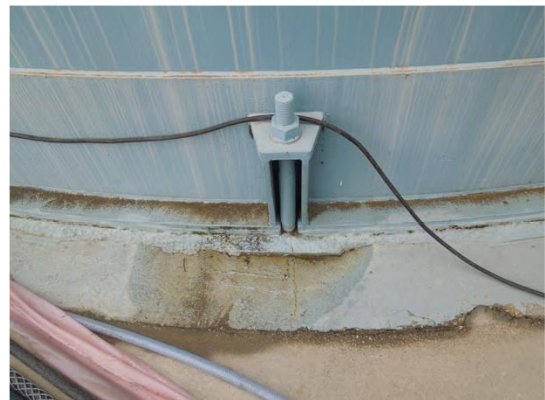
Figure 1: Condensate storage tanks 1 and 2      Figure 2: Possible signs of leakage on tank 1

There was a concern that the tanks are leaking because there were often small puddles of water nearby the tanks (Figure 2) although there were no measurable changes in the levels of tanks. The tanks are designed as a single hull construction, so there is no indication if a small leak is present. The first concern, that there might be some leaks present on tank no.1 was reported through the Corrective Action Program (CAP) already in 2013 [3]. The following inspection in 2013 was a visual inspection with the addition of ultrasonic (UT) thickness measurement by the 25 cm grid and did not find any deviations from the normal state of the component. Concern for degradation of bottom steel plates was still present, because of the scarcity of the UT thickness measurements. For the following outage in 2016 draining of both tanks was not planned, so only during the outage 2018 complete inspection was possible.

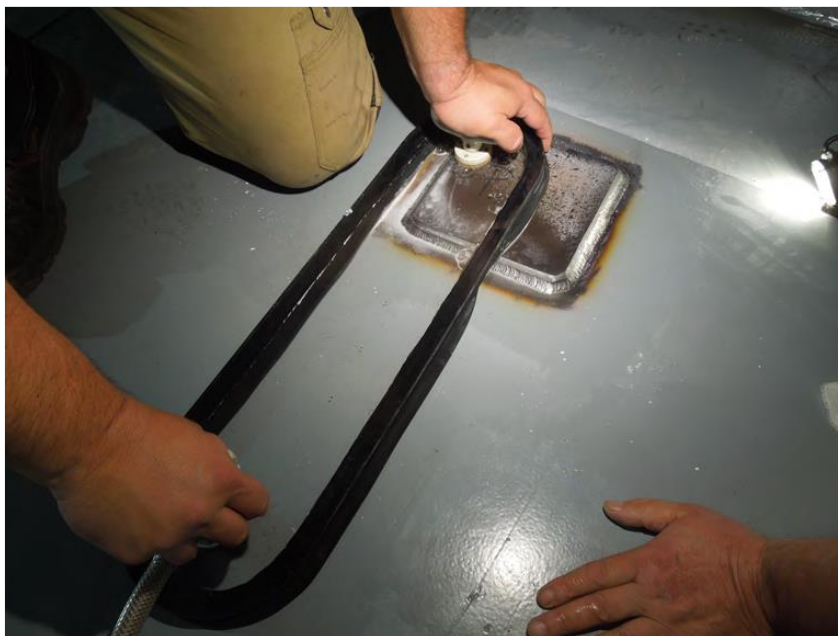
Vacuum Box testing (Figure 6) is a non-destructive method used to check for any leaks or faults in the welding of the bottom & annular plates of the storage tank. The vacuum pump attached creates a vacuum in the vacuum box, which shows bubbles of the soap water applied to the weld in case of any leaks or faults present. This is one of the most adoptive test methods to detect leaks or defects and is widely used in the inspection of tanks. Inspection of the bottom plates and adjacent welds with the vacuum box method did not reveal any leaking points.

Figure 6: Vacuum box inspection of welded patch

All damaged locations were repaired with welded patches and examined with the vacuum box method.

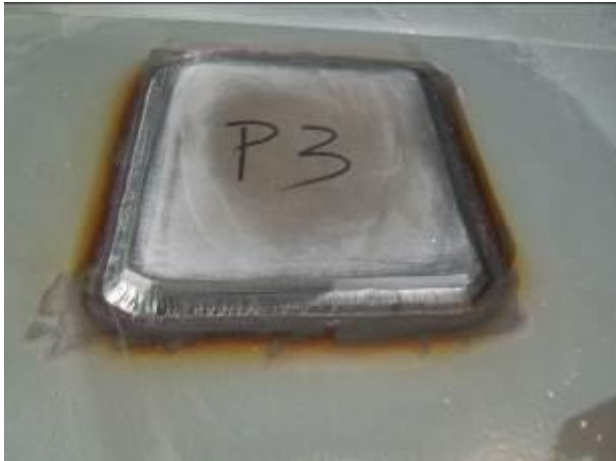
In outage 2018 CY101TNK-002 was emptied so two (2) steel plates inside CY101TNK-002 were coated with coating material Belzona 1391T (working order 126432, Figure 12 and 13). The material application was performed in accordance with product data sheet (PDS) requirements. After drying of coating system several measurements were carried out: dry film thickness, adhesion testing, and solvent resistance rub [12]. It was confirmed that the coating is properly dried and applied before closing and filling the condensate storage tank.

Figure 12: Steel plate inside CY tank

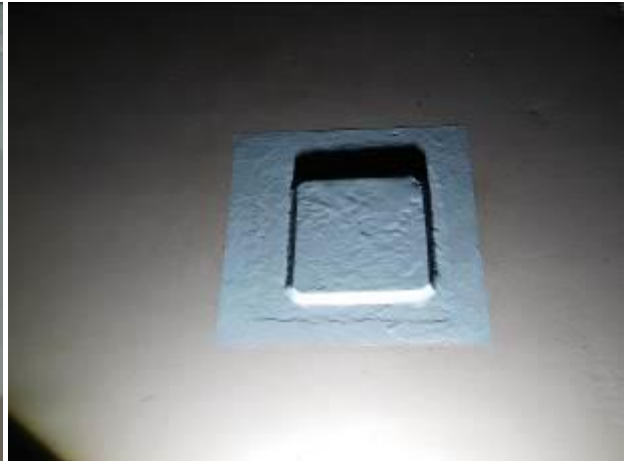
Figure 13: Coated steel plate inside CY tank

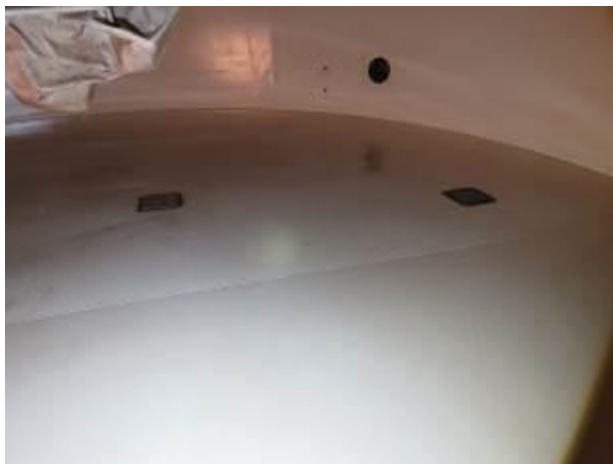
During the next outage in 2021 seven (7) steel plates inside CY101TNK-001 were coated (work order 166115, Figure 14 and 15). All required activities were implemented to ensure the adequacy of execution of coating application (DFT and adhesion measurement, solvent rub test).

Figure 14: Steel plates inside CY tank

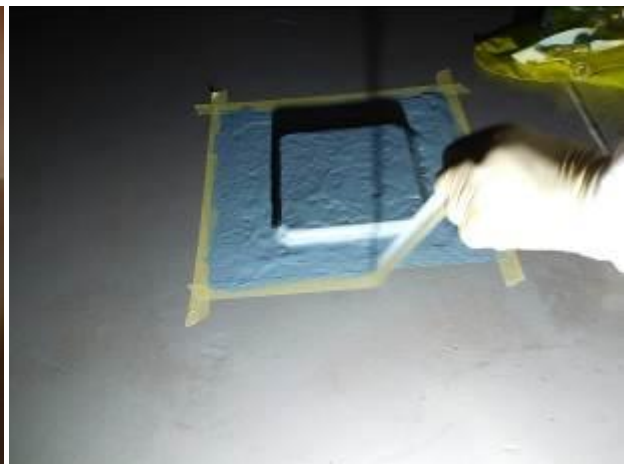
Figure 15: Coated steel plate inside CY tank
