Modernization of the Film Forming Amine Injection Skid and Performance Evaluation of the 2025 Film Forming Amine Application at Krško Nuclear Power Plant

ABSTRACT

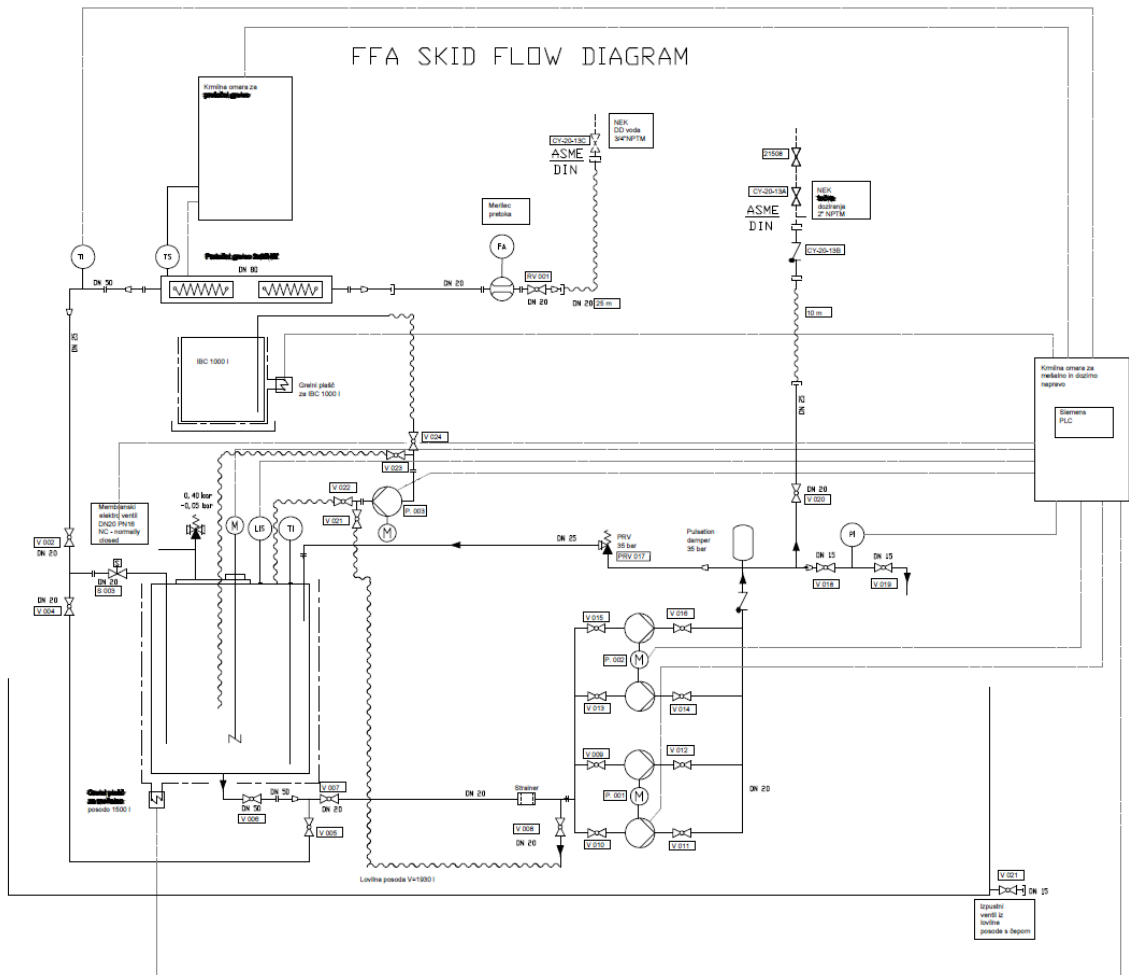
Figure 1: 2021 FFA skid design

During execution, several deviations of the FFA skid were observed, which was also documented in the final report prepared by NEKs contractor for FFA injection. The main issues concerning the FFA skid design were:

- Since the ODAICON solution was delivered in a double-layer container, the chemical had to be pumped out from the top of the tank. This method did not allow flushing of the dosing line which could lead to clogging. Therefore, an additional drum with demineralized water was used to flush the line but the water was unaccounted in the PLC as a water addition, rather as a chemical addition and therefore, the automatic counter was ineffective.

- Level measurement inside the mixing tank proved to be extremely difficult. Factors affecting accuracy are related to FFA solubility. To properly dissolve the chemical liquid the temperature must be above 60 °C and the mixer must be turned on. At this temperature and with mixing, water vapor and some foaming occurred, which interfered with the radar sensor accuracy. Since the PLC was programmed to automatically close the solenoid valve for water supply the inaccuracy of the level measurement control meant that the valve closed early or too late, thus causing a wrong FFA mixture inside the mixing tank.

- Originally prior to FFA injection the mixing tank came equipped with an inspection opening to monitor the dosing inside the mixing tank. But because of inaccurate level measurement due to fluid mixing and vapor interference this opening was utilised for an additional level sensor that was more resistant to turbulent conditions.

- During draining, it was not possible to completely empty the tank or the dosing line, therefore the draining method was improvised.
- The temperature sensor on the electrical heaters was too short and therefore responded too slowly to changes in heating of the demineralized water. That resulted in overheating the demineralised water inside the mixing tank which accelerated vapour forming inside the mixing tank and therefore propagating the level measurement inaccuracy. Hysteresis and temperature variation inside the mixing tank were too large, meaning the cooling phase lasted too long, resulting in an inadequate FFA concentration in the mixing tank.

- FFA skid was also inadequately designed for leaning after the injection.
- PLC programming was performed in a way that the programme did not account for problems that could occur with level instrumentation, water temperature monitoring, chemical dose pump rinsing issues, inability of skid draining, etc... and was therefore, in part responsible for an inconsistent chemical dosing rate to the secondary water steam cycle (WSC).

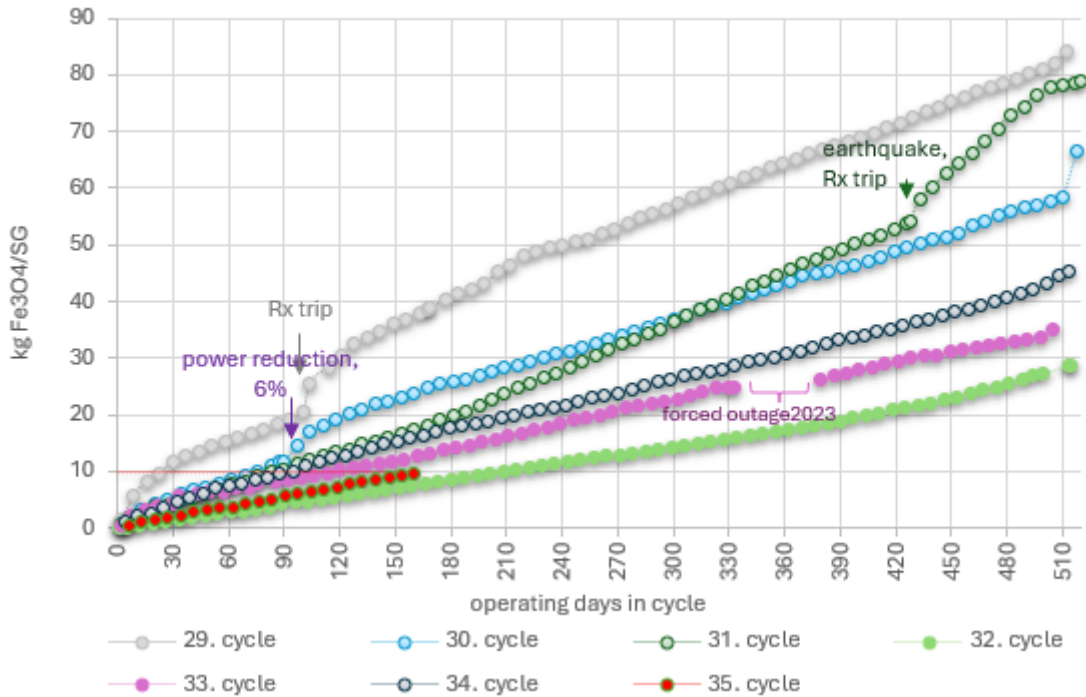
Figure 3: Cumulative Fe_3O_4 deposition to SGs during OL 29-OL35 cycle

Figure 3 shows trends of cumulative Fe₃O₄ deposition to SGs before applying first FFA application in 2021, between 2021 and 2025 FFA campaigns and after second FFA application in 2025 (OL29-OL35 cycle). After the first FFA application in 2021, the expected effect after the addition of the ODACON®F solution was the formation of a mono-molecular hydrophobic film, which was adsorbed on metal surfaces and consequently lower release of iron and iron oxides in OL32. Particulate iron measurements, which were performed before the Rx shutdown on OL31 and after the first FFA application showed less release of iron prior FFA injection. Cumulative Fe₃O₄ deposition to SGs was much lower than before. Visual inspection and tests on the surfaces of the condenser, moisture separator (MSR) and heat exchanger (HEX) in RE 2021, confirmed the desired behaviour of water droplets and the formation of hydrophobic film, as a result of the application. During OL32-OL34 period figure 3 shows gradual increase of iron and iron oxides release. After re-

application of FFA at the end of OL34, the release of iron and iron oxides in OL35 is almost at the same level as in OL32.

FFA applications were successful from the chemical standpoint. FFA had a positive contribution to plant operation, as evidenced by record-low trends of measured iron in the condensate (CY) and feedwater (FW) system during plant operation. It is recommended to perform the FFA application every third cycle or optional every second cycle (based on the cumulative amount of Iron in the secondary side).

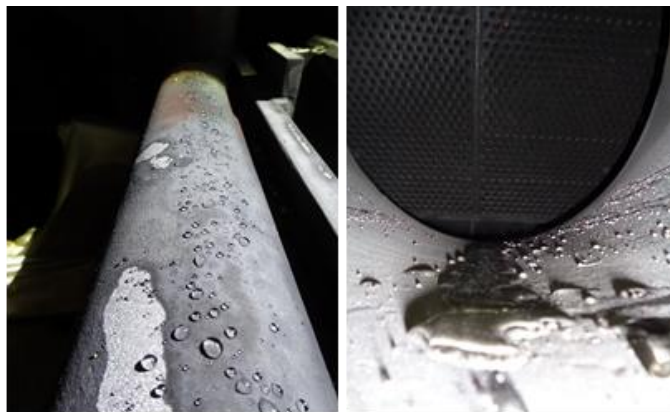
Figure 4: Visual inspection of condenser and MSR (during outage 2025)

During the following outage right after the FFA re-application, a few components were visually examined such as: MSR, Heater 6A, Condenser and Condensate Transfer Tank. Figure 4 shows the photographs taken during visual inspection in Outage 2025 for some components. It can be seen that hydrophobic layer of FFA was successfully formatted on internal surfaces.
