## Corrosion Detection and Surface Repair with Coatings on Condensate Storage Tanks Internal Surfaces

Nuklearna elektrarna Krško

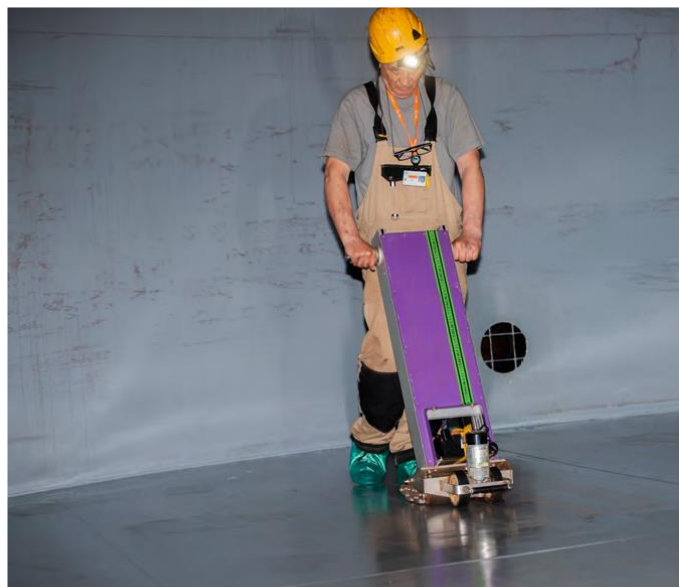
Figure 5: Inspection of bottom plates using MFL detection scanner.

Inspection of the bottom plates with the MFL method (Figure 5) was performed due to the determination (identification) of pitting corrosion from underneath (bottom side of the plates).
